AIRWAYS CLASSICS N° 2

TWA Flight 800

The Devil is in the Details

by Robert W Allardyce & Captain Howard Mann (TWA, retired)

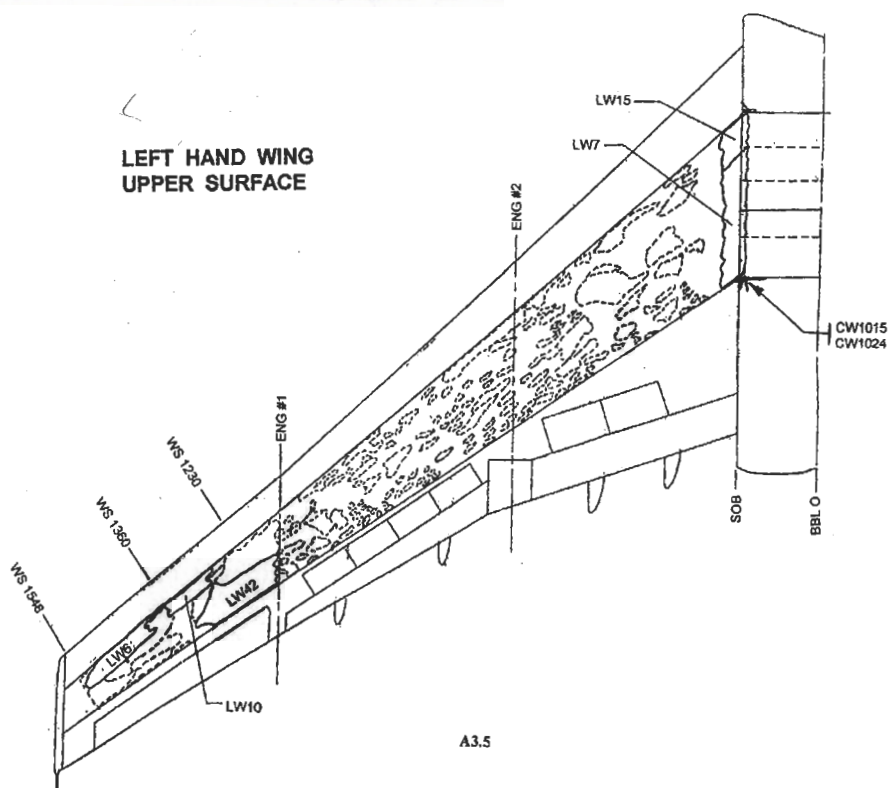
LEFT HAND WING UPPER SURFACE

In reporting the condition of the wrecked left wingtip (above)—another loose end—the NTSB states: "The left wing outboard of about Wing Station (WS) 1230 [outboard of engine N° 1] broke into eight larger pieces and numerous smaller pieces. Layout of these pieces showed upward bending outboard of about WS 1230 (LW 8 & LW 42) and possible down bending outboard of WS 1360 (LW 5 & 6, LW 44). Both upper and lower wing skin panels between WS 1230 and WS 1380 showed upward curling at the inboard end (upper panel LW 42 and lower panel LW 8)." Between WS 1230 and WS 1360 is where the wingtip broke free.

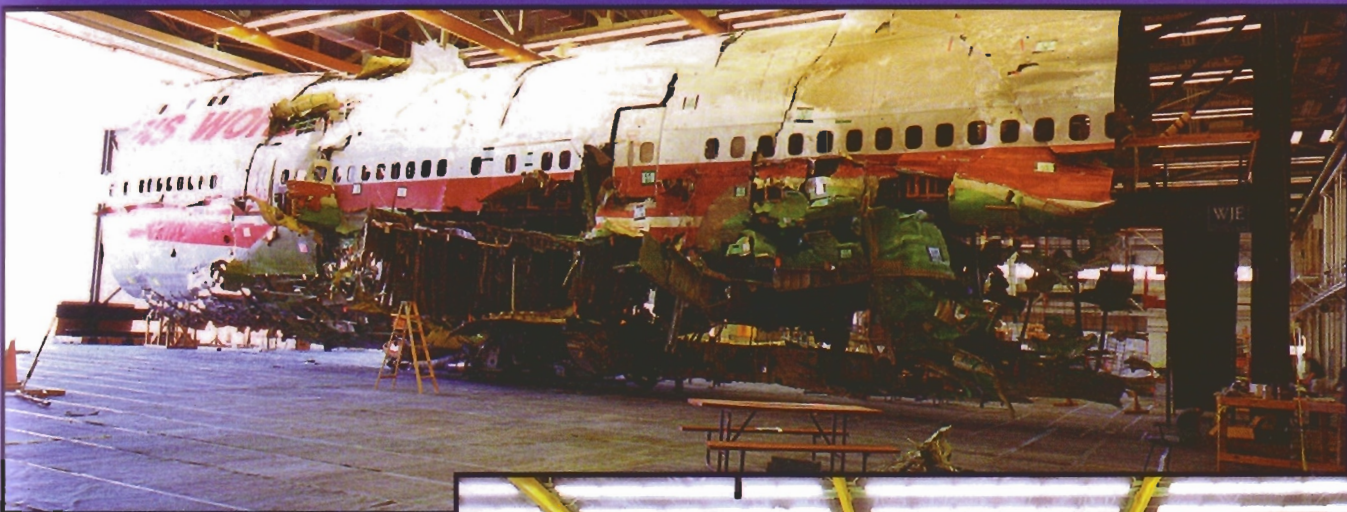
Original fuselage reconstruction. Another NTSB photograph shows that, unlike the left side, the skin of the right side of the forward section is splayed outward (that is from left to right). This is the result of a linear rather than an expanding omni-directional force emanating from the opposite side of the airframe.

complicated mathematical calculations and was able to triangulate the epicenter of the blast. Accordingly, Donaldson placed the epicenter near the "Low[er] left side [of the fuselage]...abeam aircraft station 576." Donaldson adds: "9 feet [2.74m] below the aircraft belly line [and] 17 feet [5.18m] from closest aircraft hull" (left). An NTSB diagram depicts the L2 door, located nearly abeam the epicenter of the explosion, having been blown loose and expelled from left to right. The opposite would have been true had the explosive pressure emanated from the CWT.
